Basin 13: Connecticut River and minor tributaries

Report 74, Bellows Falls, Connecticut River, Bellows Falls, Windham County, Vermont and Walpole, Cheshire County, New Hampshire.

Report 75, Lulls Brook Gorge, Lulls Brook, Hartland, Windsor County, Vermont.

Report 76, Sumner Falls, Connecticut River, Hartland, Windsor County, Vermont, and Plainfield, New Hampshire

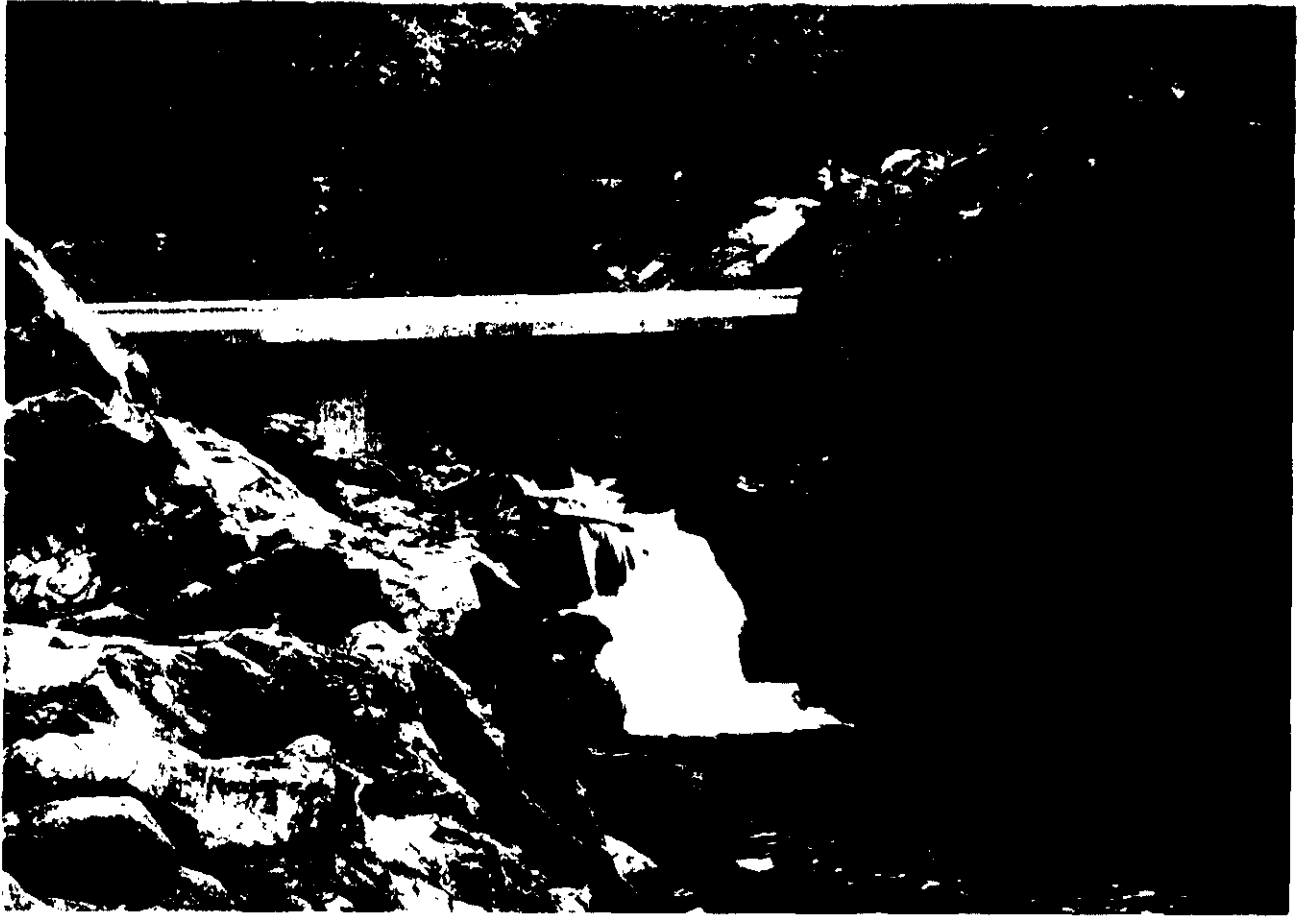
BELLOWS FALLS

The dam is perhaps 40 feet high and 120 yards across. Below it, there is a second smaller dam, then a small cascade, then a gorge perhaps 100 yards long and 40 feet deep. The walls of the gorge are vertical and chunky, and there are only a few small potholes and no real sculpture. The gorge is spectacular when the water pours through it but not very impressive when dry.

The rock is Bethlehem gneiss of middle Devonian, a common rock in New Hampshire but limited to Bellows Falls in Vermont.
